## EARLY MEDIEVAL HILLFORTS

### Comments on the Construction and Lifespan of Fortifications Based on Modern Reconstructions in Modrá near Velehrad<sup>1</sup>

LUDEK GALUSKA

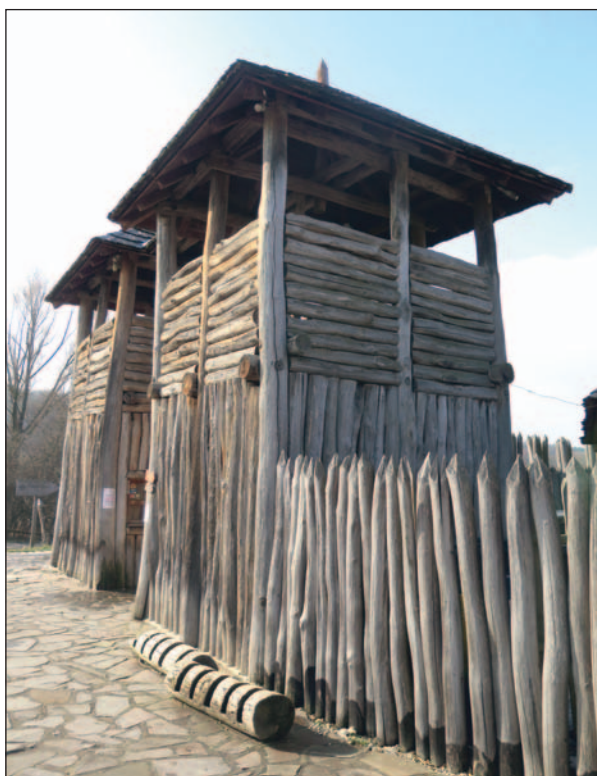
Fig. 2. Modrá. The wooden double gate with two towers.

Until 2021, the wooden double gate with two towers (Fig. 2) was technologically the most complex construction in the archaeological open-air museum in Modrá. Square towers – with 300 cm long sides – are supported by four oak poles and four further poles placed in-between that are 600 cm high and

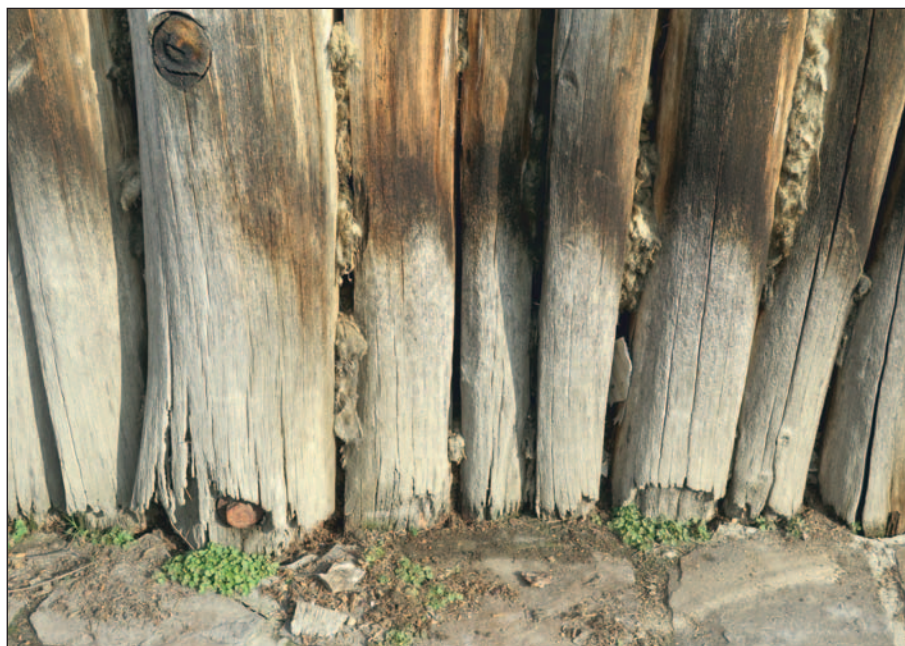
Fig. 3. Modrá. Oak poles of the entry tower embedded in concrete twenty years after construction with legible traces of rain water effects.

So far, the towers, as well as the entrance gate to the archaeological open-air museum in Modrá, have not required any repairs. The entire construction is still sufficiently stable. Rainwater, however, harms its lower parts. After dripping from the roof onto the surrounding mortar-stone floor, the rainwater sprays poles and the shell that soaks up to 60 cm over the ground. At the floor level, thus, sapwood had already decayed – only the heartwood remained. Finally, due to various chemical processes, the wood changed colour into grey and, thus, looks old (*Žák/Reinprecht 1998*). Nevertheless, after nearly twenty years, the towers are still stable and solid.

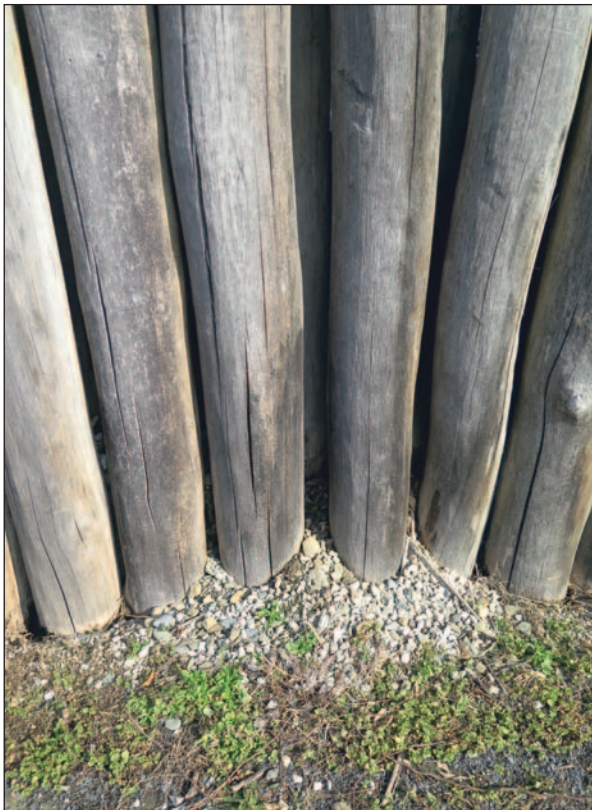
Fig. 4. Modrá. Oak poles of the palisade embedded in crushed stones.

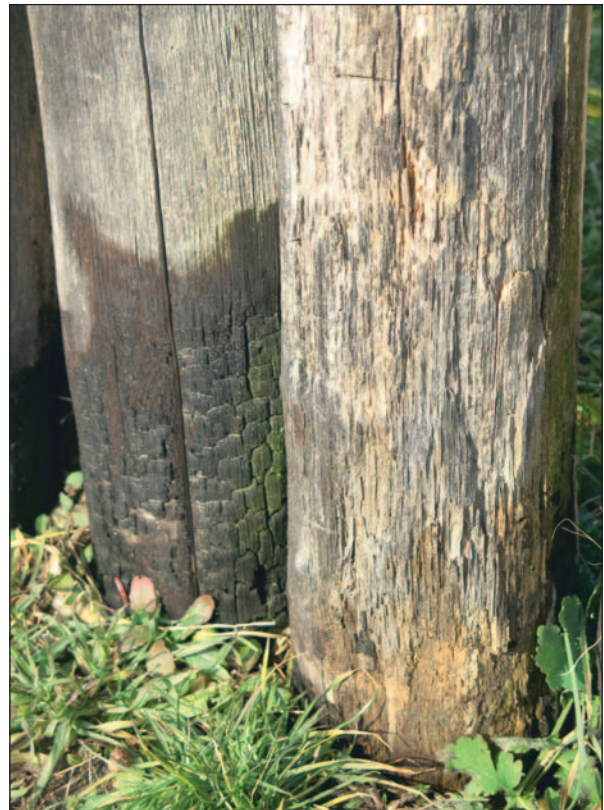
Fig. 5. Modrá. Oak poles of the palisade: on the left well charred, on the right improperly charred.

after 12–13 years, poles fixed in concrete on the peak of Havránok above Liptovská Mara still contained at least 70–80% of healthy matter (*Makýš 2018*, 128). It seems that the inconsistencies could be caused by different natural conditions and the type of wood used. While in Modrá we have used deciduous oaks, on Havránok the researchers used larch (*Larix decidua*) or, more generally, conifer trees (Fig. 5).

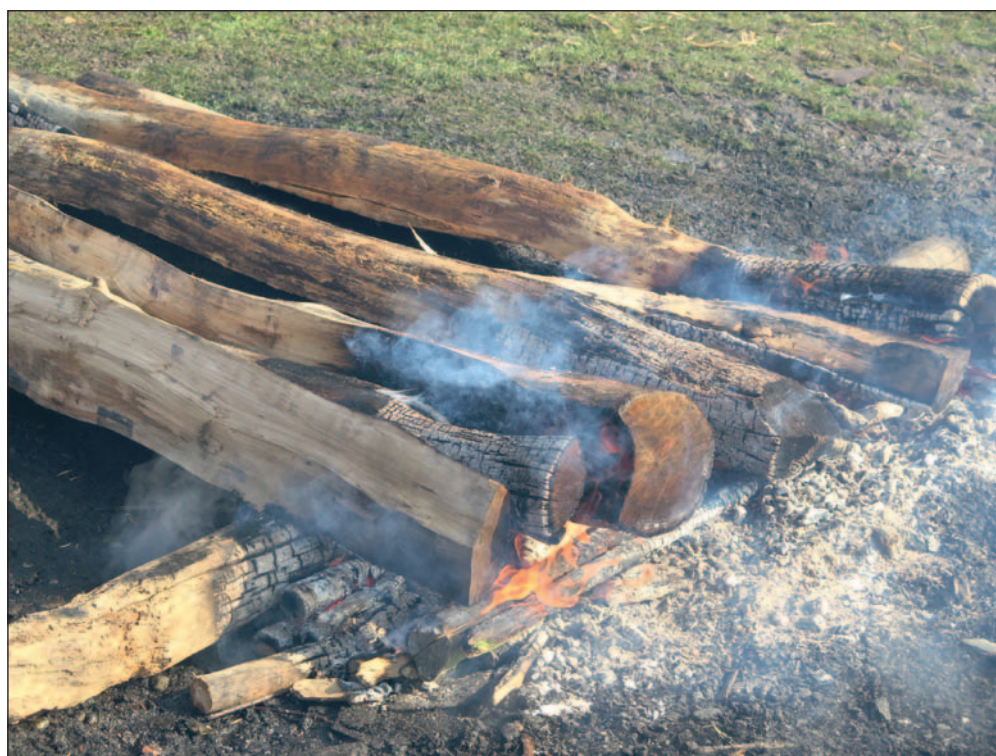
Fig. 6. Modrá. Charring lower parts of oak beams.

2014, fig. 2: 1: 5). Preparing wood in Modrá, we used experiences of the old masters. During frosts, we took larch that rested one month on a slope, trunk up and branches down the slope. Then bark and branches were removed and grooves carved using chisels and axes (Fig. 8). At this point, however, we decided to modify the traditional process and use a gas burner. Burning a three-meter long groove took about one hour (100 cm/20 minutes). Using hooks and branches we have placed the gutter below the roof (Fig. 9), where it is functioning very well already for 5 years without any repairs. Based on all these, we can conclude that in Modrá, deep charring proved to be an efficient technique of preserving poles.

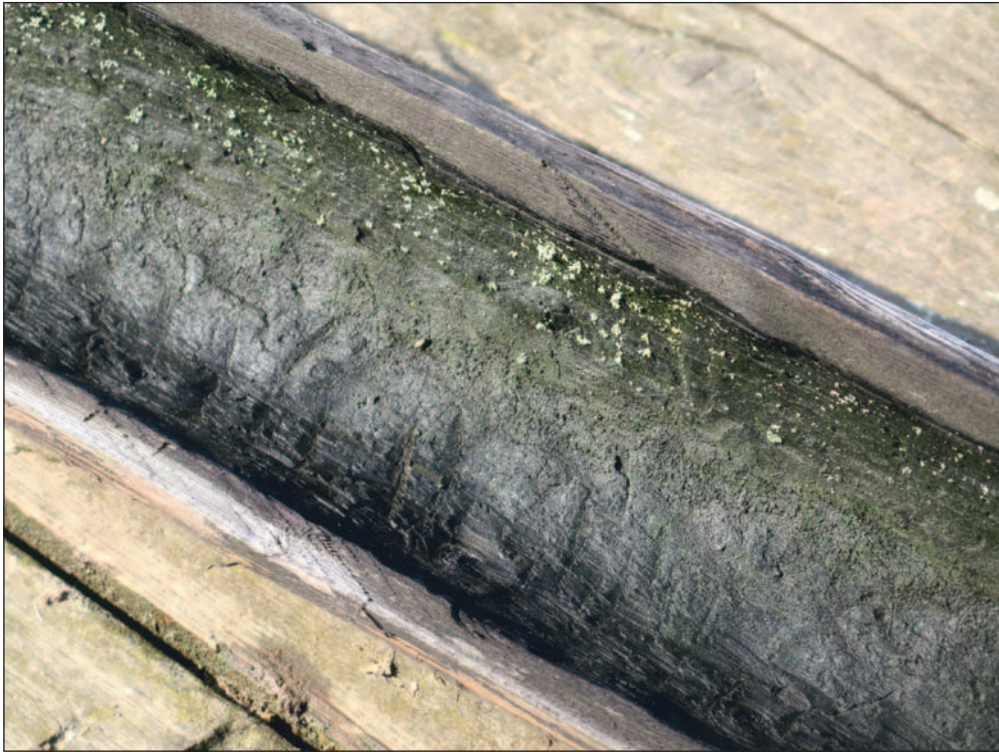
Fig. 8. Modrá. Details of a charred wooden gutter.

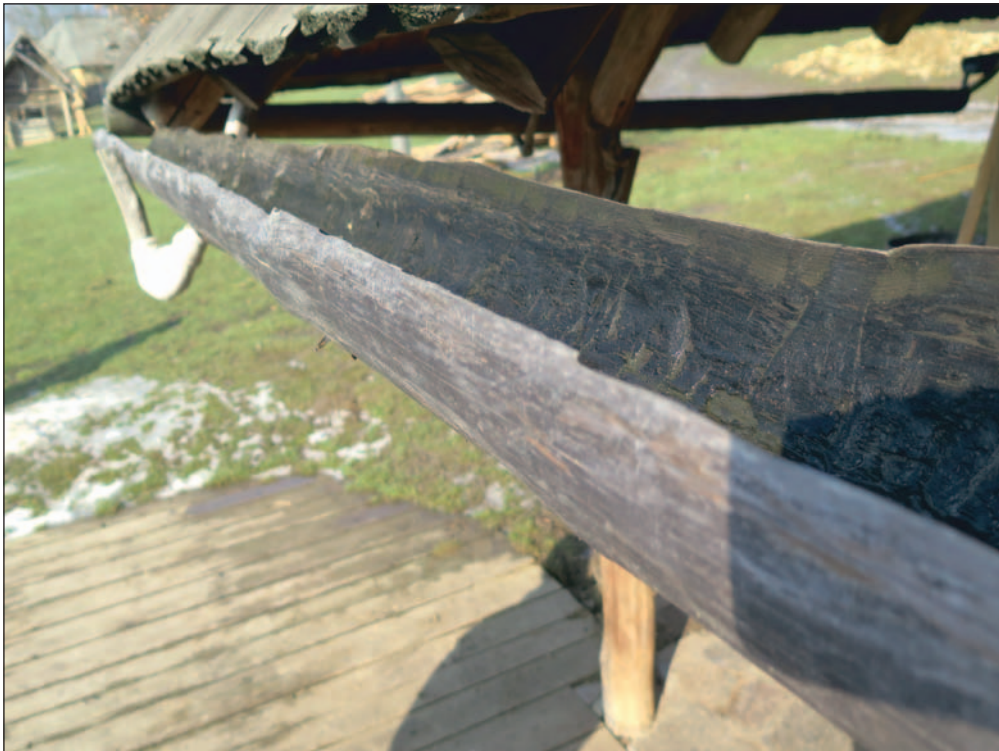
Fig. 9. Modrá. A wooden gutter and its attachment to the lower part of the roof.

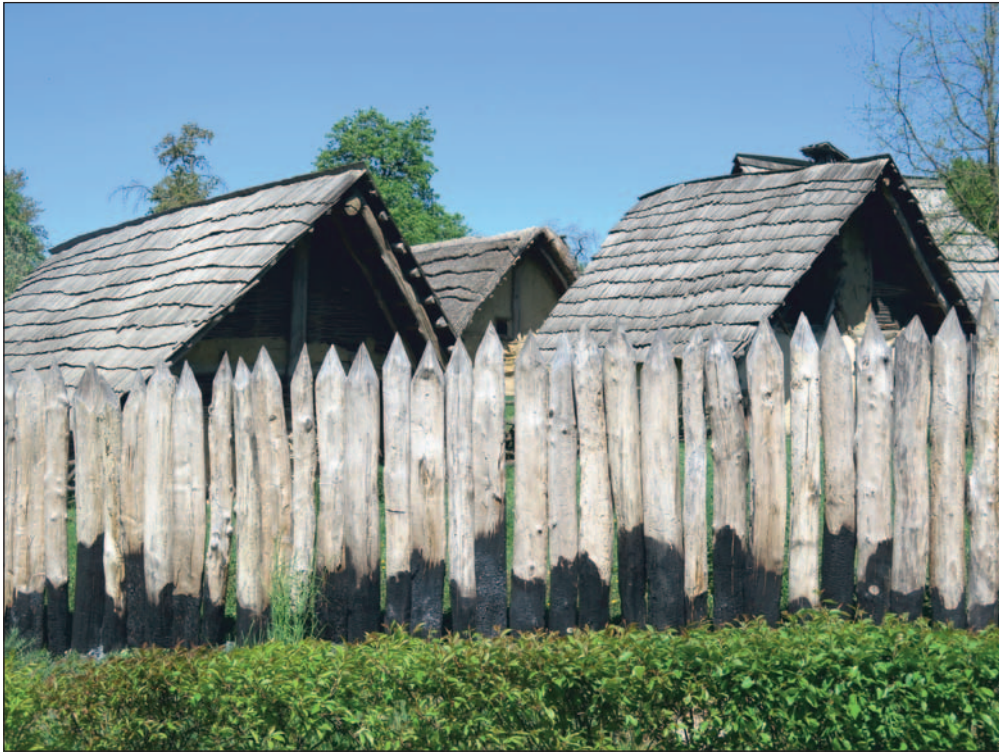
Fig. 10. Modrá. A palisade wall surrounding the archaeological open-air museum with well charred oak poles embedded in crushed stones.

In 2011, all palisade walls, as well as the wooden-soil shell construction (Fig. 10; 11), were replaced. All concrete elements were removed because they proved to be useless. Instead, we dug ditches (60 cm deep) filled with a 10 cm thick layer of stones. Subsequently, we put deeply charred poles (250 cm high/20–25 cm diam.) on the stones and covered them with the next layer of stones. The construction of the front wall of the new shell fortification was similar. The only difference was that it consisted of a double row of poles. The solution allowed strengthening the wall in terms of statics and defensive characteristics. The poles used were 20–30 cm in diam. all. Half of the poles were 270 cm

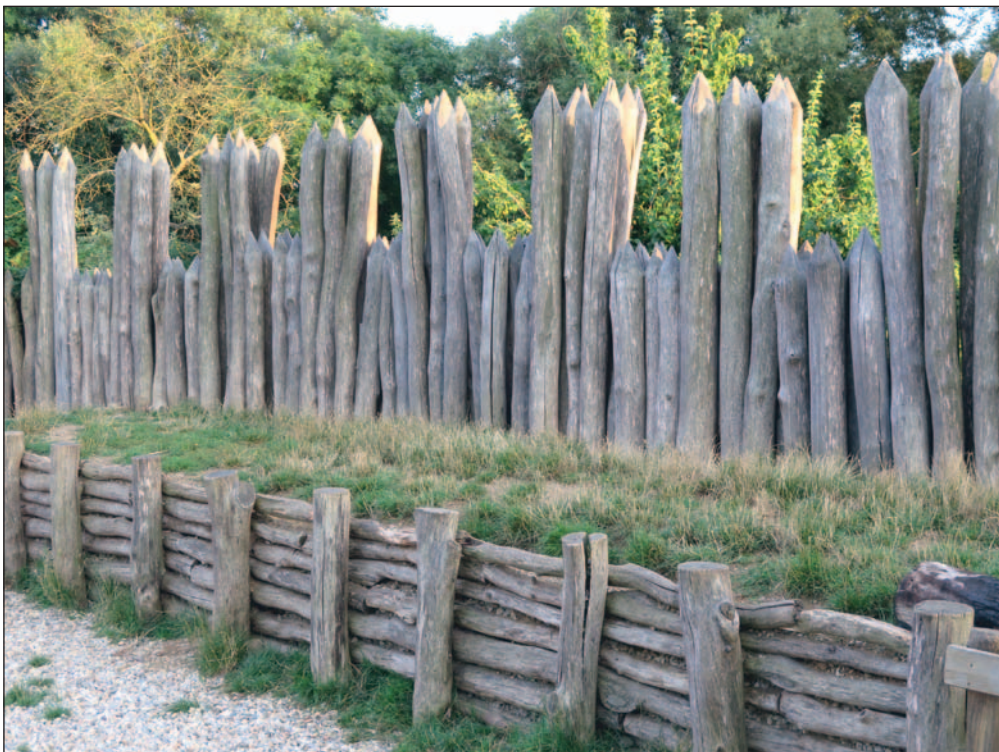
Fig. 11. Modrá. The palisade back sides of the shell fortifications, reconstruction of the so-called Christin's wall.

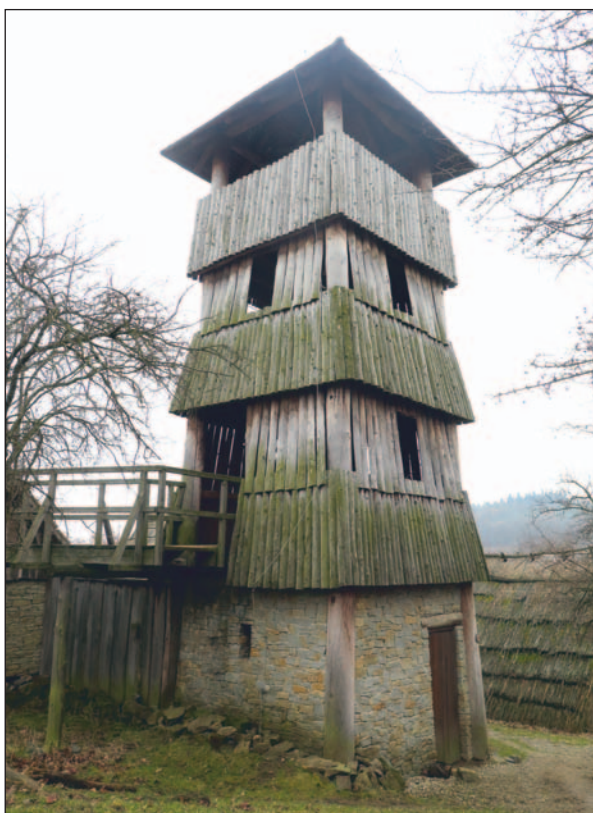
Fig. 12. Modrá. The watchtower with stone foundations and wooden constructions made of red spruce.

In 2011, another construction was built in Modrá: a 1,300 cm high, square, three-storey watchtower (Fig. 12). The tower rests on four massive corner poles (50 cm diam. in the lower part) and four further poles placed in-between. Generally, the tower

is supported by eight 1,100 cm high timber stakes made of larch. All poles are combined with iron belts. Additionally, the tower walls are strengthened with mortared stones between the poles on the ground floor. The construction is covered with a four-sided (hipped) roof made of spruce shingles. The cladding consists of four vertical half logs with openings for archers. The top floor lacks cladding and thus offers a nice view of the surrounding countryside. Such high and heavy constructions pose a great stability challenge to prevent the building from collapsing or sliding. At present, the tower is stabilised by massive iron pins fastened in the centre of each supporting pole and fixed in a concrete bed. Foundations of the poles are not put directly in the soil; thus, the negative effects of wood-damaging factors are limited. However, the disadvantage of this solution is that the spot requires ‘a cover’, for example, lined with stones. The tower stands on the highest spot in the archaeological open-air museum and serves primarily as a viewpoint.

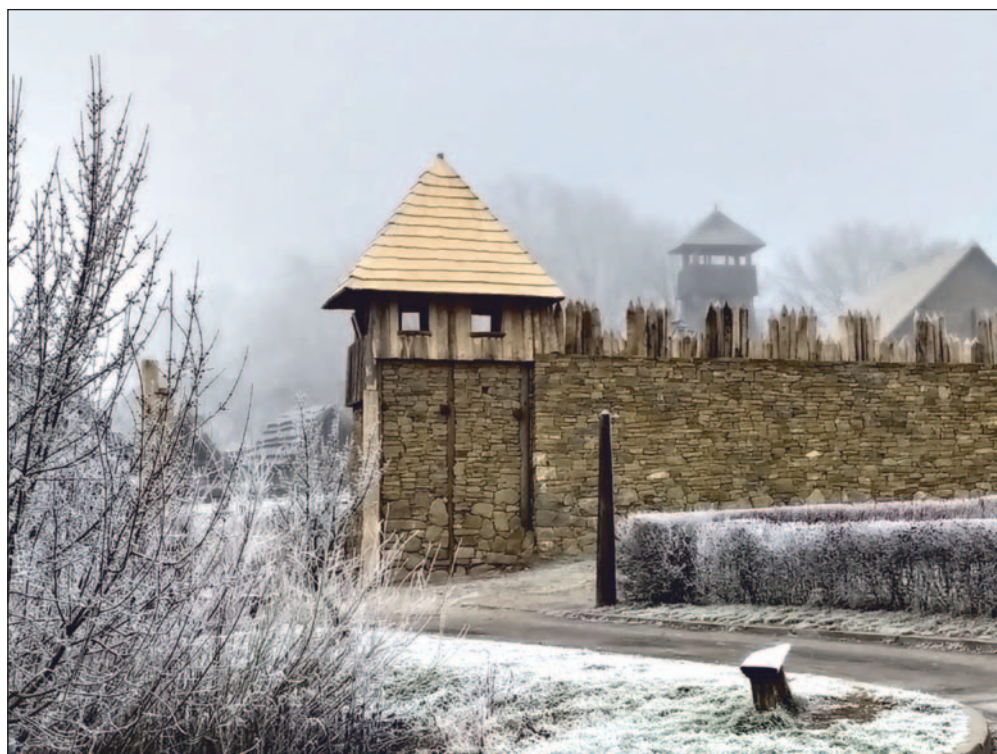
Fig. 13. Modrá. The archaeological open-air museum and its new landmark – fortifications with a stone wall (photo by M. Kovářík).

The most distinctive fortification construction in Modrá is the rampart with stone front wall, wooden-soil construction and rear retaining wall. The fortification was built in 2020 and the first half of 2021 (Fig. 13; 14). It is a hypothetical reconstruction of fortifications discovered during research in Uherské Hradiště-Rybárny (*Galuška 2006; cf. Procházka 2009, 219–221*). The original construction was part of the outer fortification system of the Staré Město – Uherské Hradiště agglomeration (Veligrad) and was built at the end of the 9<sup>th</sup> c. in the final phase of the existence of the Great Moravian state (*Galuška 1998; 2017, 135–139*). The front dry-stone wall was 200 cm wide at the wall foot. The rampart – marked with a palisade stretching along the inner wall and the retaining wall at the rear of the fortification – was 630 cm wide with 700 cm retaining poles. The total width of the construction was, thus, 900 cm. In the space between those two walls, there were found remains of transverse beams aimed transversely towards the fortification. There were also traces of beams laid parallel to the fortification. Therefore, it seems likely that either 1) the fortification core consisted of wooden chambers filled with soil or 2) there were only transverse tie beams that linked the rear wall made of poles with the front wall or

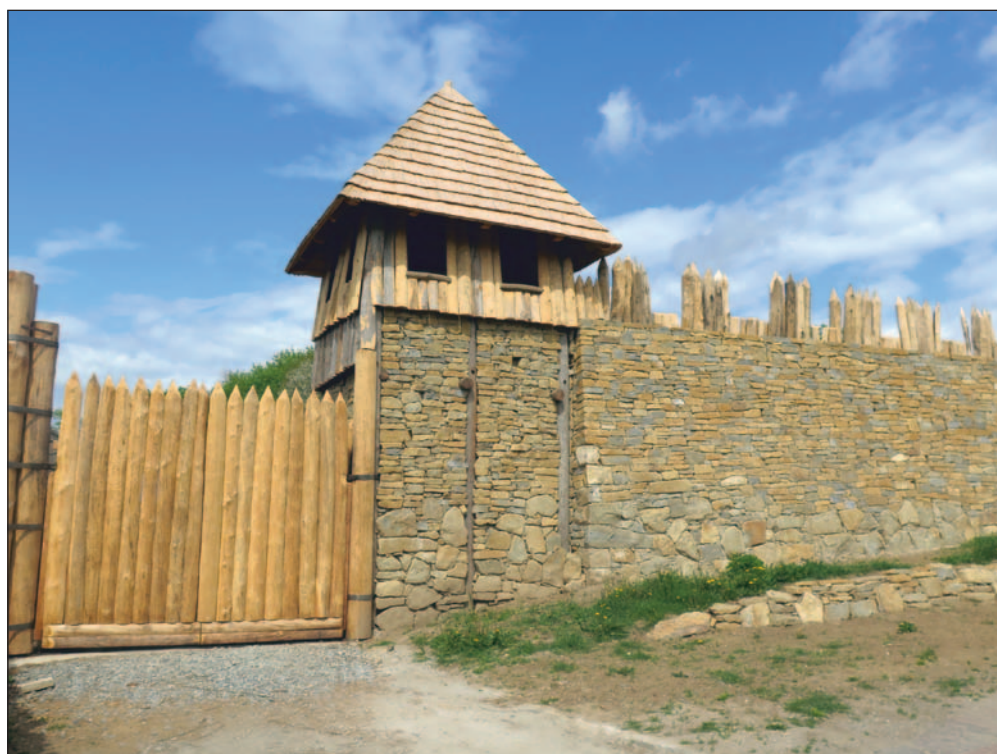
Fig. 14. Modrá. The gate, defensive tower and fortifications with front stone wall, front view.

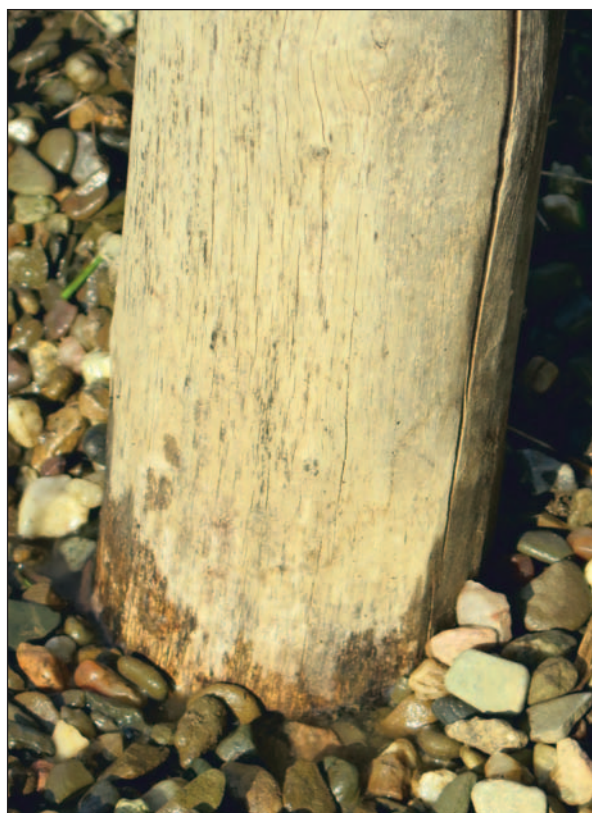
Fig. 15. Modrá. A red spruce pole from the well, embedded in gravel pebbles.

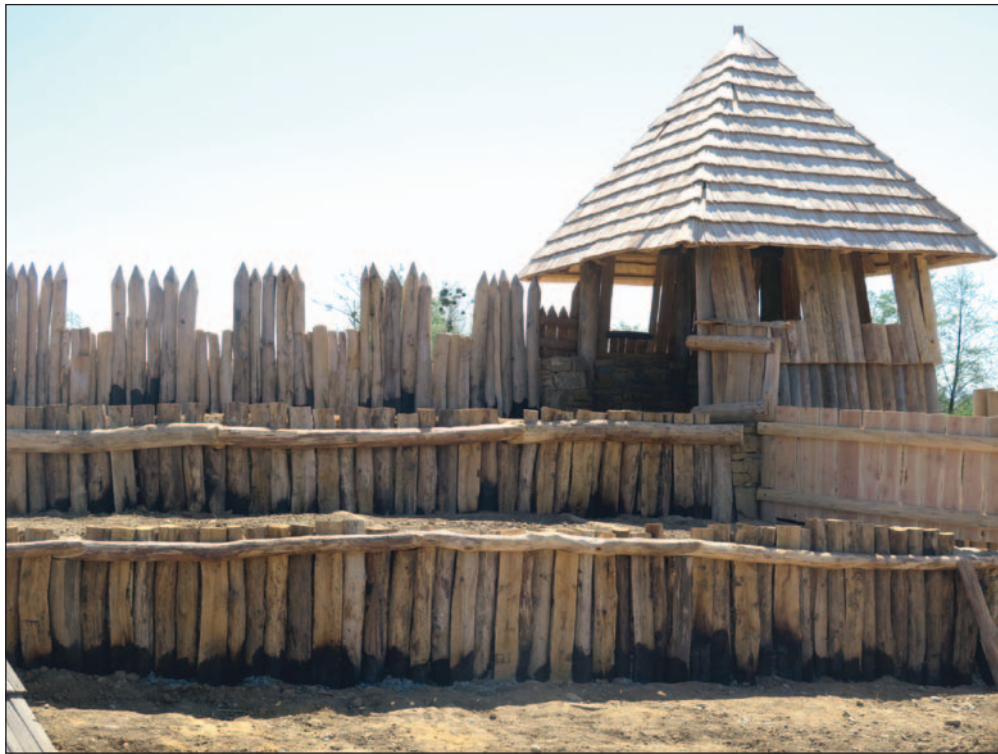
Fig. 16. Modrá. The stepped body of the wooden-soil construction of the fortifications and the defensive tower, back view.

The defensive tower (Fig. 16) – to the right of the gate – links with the southern end of the fortifications. The tower is not a reconstruction of any

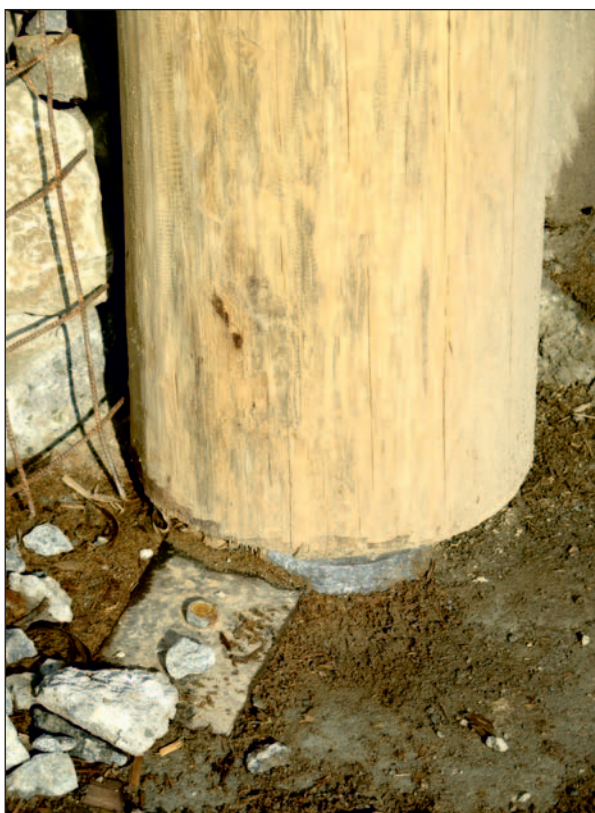
Fig. 17. Modrá. Details of the lower part of a red spruce pole from the gate construction on a lead pad.

through the northern tower of the main museum entrance. The main supporting poles of the tower and the gate are fixed with iron pins to the concrete foundations – similarly as in the case of the watchtower. However, we have introduced some improvements. Between wood and concrete, iron pins are coated with a lead insert – about 2 cm thick and 8–12 cm in diam. (Fig. 17). It turns out that lead (as well as copper and zinc) is very efficient in preserving wood against fungi and wood damaging insects. Twenty-one years ago, the method was used to preserve the foundations of a wooden cross at a hypothetical reconstruction of the early medieval St. John's church in Modrá. To this day, the cross stands on the spot unaffected by weather or wood damaging factors. It is worth mentioning that the total length of the fortifications and the tower is 17 m. Together with the gate, the construction is 20 m long. So far, no similar reconstruction endeavour with fortifications including a front stone wall has ever been undertaken in any other archaeological open-air museum.

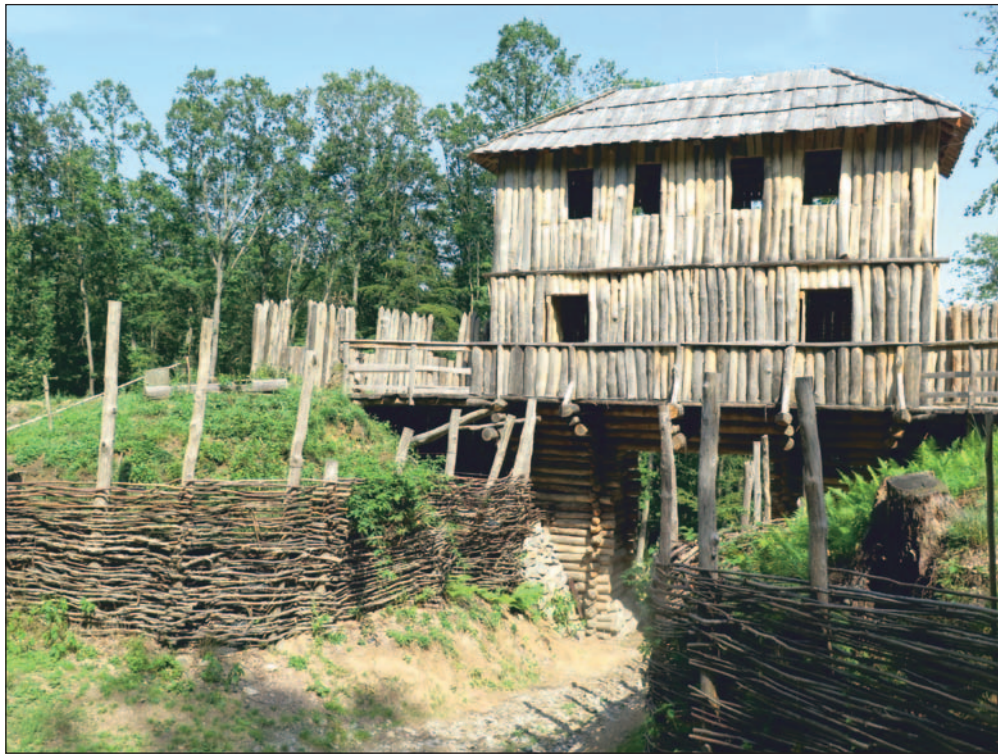
Fig. 18. Bojná. The reconstructed eastern gate, back view.

To some extent, the constructions from Modrá near Velehrad can be compared with recent reconstructions on site of the upland Bojná-Valy hillfort (Fig. 18) in Western Slovakia (*Pieta* 2007; 2012; 2017; *Pieta/Ruttikay* 2018, 15–21). The reconstruction, in the true sense of the word, answers to the issue of protection and presentation of those fortifications that were negatively affected by human activities in the past and are now a subject of archaeological research. This applies mainly to the entrances-gates which, for decades, served as passages for heavy equipment of lumberjacks and places where the ramparts have been intersected to investigate their internal structure. The main assumption of the reconstructions on site of the trenches is to apply the knowledge gained during research to restore wooden and stone construction elements in a position consistent with that in the core of the original fortifications. Consequently, the reconstructions cannot be considered hypothetical (*Pieta* 2017, 20–27). The current condition of wooden elements protruding from the front and rear parts of those reconstructions indicates traces of activities of wood damaging factors and weathering. The situation seems better where wood directly touches stones, whether the stones are hardcore or stone walls. Interestingly, the reconstruction uses also wattle fences on vertical poles or woven walls supported by pillars. When it comes to strength and statics, however, such elements are not considered very durable (*Procházka* 2009, 255). The Bojná I hillfort is visually dominated by the eastern gate reconstruction built in 2018 on-site of the original entrance. Its appearance is based

on the results of archaeological research and an architectural project by a team of professionals (Makýš 2018). The construction was carried by the village of Bojná and supported by the Ministry of Culture SR with the supervision of professional committees. It is a large rectangular construction with a two-storey tower over the gate. The facade is covered with half log siding with openings for archers. The hipped roof is covered with boards. The tower rests on two square log constructions made of horizontal poles and strengthened with additional poles in the upper part. Between those two constructions, there is an entrance to the hillfort. At both sides of the log construction, there are partially reconstructed fortifications with front foundations made of stones and a palisade wall on the top. The footpath on both sides allows access to the tower. Generally, the reconstruction is impressive, perhaps somehow oversized, particularly when it comes to the tower dimensions. Certainly, it will be reasonable to observe how the known negative factors will affect the reconstruction in the future since already after two years from its construction (2020), the woven wall on the right side of the gate broke. This, however, does not challenge the fact that the Bojná I hillfort – not only due to remarkable finds but also its three-dimensional reconstructions – deservedly attracts both professional as well as lay interest.

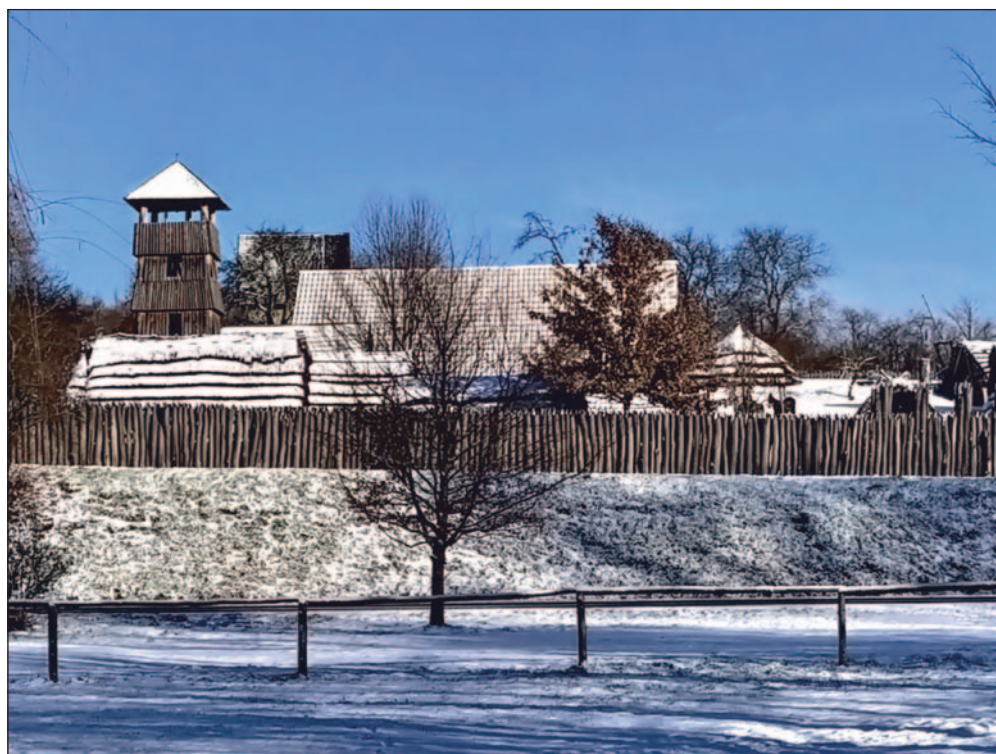
Fig. 19. Modrá. The archaeological open-air museum, view from the south.

Currently, due to wood damaging factors and weathering, the lifespan of poles in palisades and single walls of light shell fortifications does not exceed 10–12 years (Fig. 19). This, however, is inconsistent with conclusions of B. Dostál, who estimated
