JOZEF MALGOT* — FRANTIŠEK BALIAK* — TIBOR MAHR* — RUDOLF
ONDRÁŠIK** — JOZEF SIKORA*** — JÁN ŠAJGALÍK*

ENGINEERING GEOLOGICAL RESEARCH FOR THE STREČNO CASTLE SAVING

Abstract: The steep rock wall of the lithologically and tectonically heterogeneous calcareous-dolomitic bluff, on the top of which stand the protected ruins of the Strečno castle, is affected by rock falls and rock blocks, which pulled down already one part of the peripheral walls and threaten the remaining ones. In order to secure them, it was necessary to carry out a pretentious, time-limited engineering geological research of stability of the rock wall below the castle, to evaluate the extent and measure of threatening of the castle foundations and to suggest efficient measures to secure them within the course of reconstruction works on the castle. The most important results of the research form the content of this contribution.

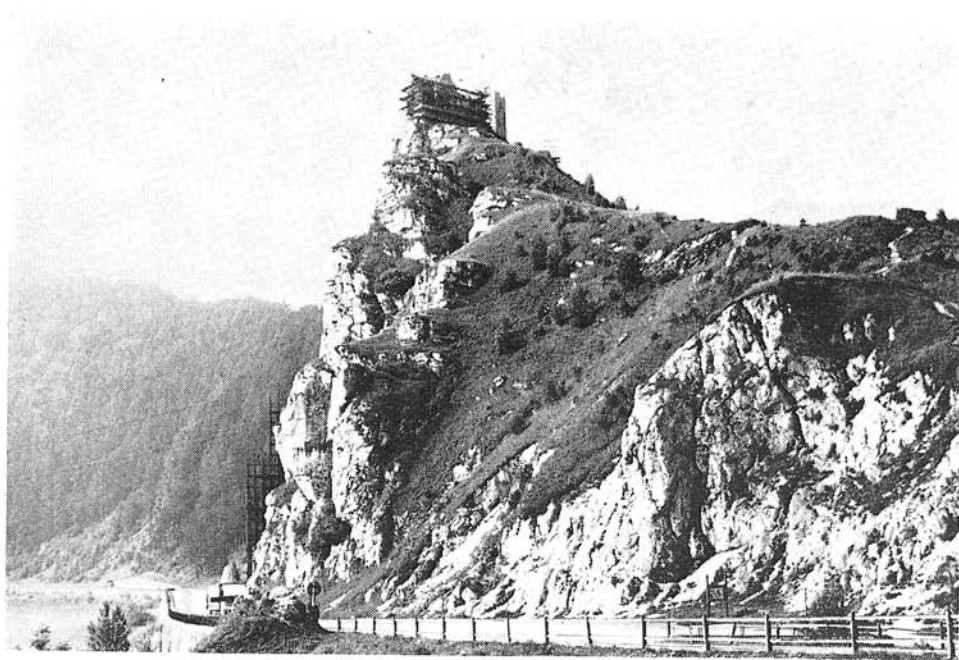
Fig. 3. North lateral view on the castle rock on the buffer bank of the Váh entrenched meandre.

Explanations: 1 — calcareous-dolomitic complex (Middle Trias); 2 — dolomites (Upper Trias, 2—3 the Choč unit); 3 — the course of tectonics.

The terrace level points to the fact that a rapid upheaval and a deep erosion of the Váh took place in the Quaternary. The castle wall lies in the place, where important deformations are intersecting, which predetermined the direction of the Váh, so that during the entire erosional development it formed a buffer bank within the frame of the tectonically predetermined entrenched meanders (Fig. 1 and 3).

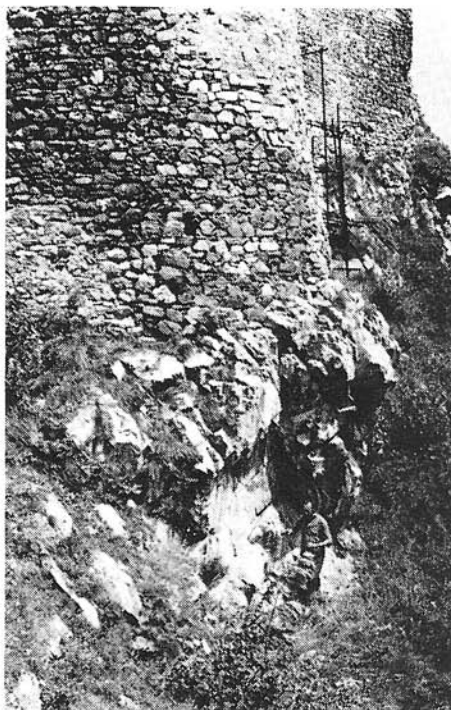
PROFILE 2

Fig. 12. Profile of the base of the Large rampart (section 2) threatened by the overhang fall. Saving-anchors, micropilots and bricking up. Orientation of anchors is suggested according to tectogram. On the photograph we can see the system of deformation of the rampart base.

In each of the delineated sections we constructed by a stereocomparator a detailed profile on scale 1:200. Then in each we drew all the principal discontinuities detected in the direct field research, which are affecting more significantly the stability of the castle subsoil. All the studied discontinuities have their indication in the profiles and in the tectonograms. The profiles enabled us to make a diagram representation of the suggested saving and stabilization works. For illustration we append also a photograph to each profile. The examples of typical detailed profiles of the castle subsoil with the suggestion for saving and the characteristic photograph are in Fig. 12, 13, 14.

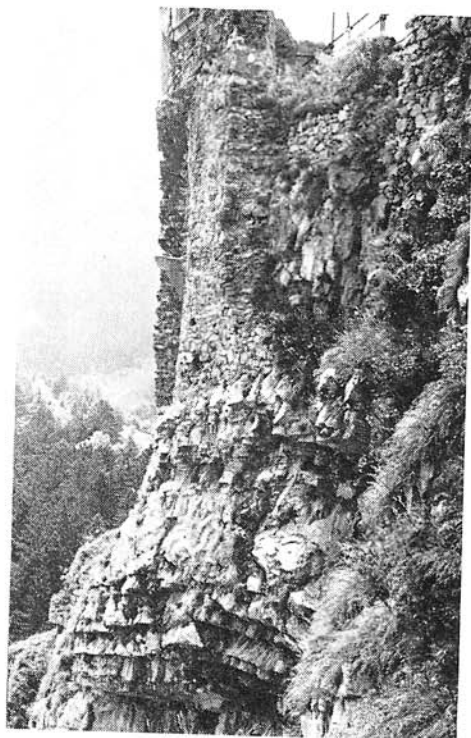
PROFILE 4

Fig. 13. Detailed profile of base of the southern palace (section 4). Discontinuities 2/1 and 1/1 were detected in the castle area. The anchors must reach beyond the last dangerous discontinuities. The photograph shows the overhang, which must be bricked up.
