PRELIMINARY REPORT  
ON THE DUWEYM WAD HAJ SEASON 2022  
<https://doi.org/10.31577/aassav.2022.31.2.08>

This contribution reports on results of multidisciplinary research in Duweym Wad Haj in January and February 2022. The archaeological excavations focused on the internal structures and architecture of the old mosque and discovered eleven residuals of bases of pillars and/or columns of a *riwaq*. These results indicate the existence of the *riwaq* along all the perimeter walls, with a different number of arcades along each wall, which enclosed an open internal yard. The soil survey confirmed a ca 7 metres high eolian dune below the old mosque, without traces of any significant settlement down to a depth of ca 5.5 m. Research on the mudbricks and construction of the old mosque confirmed its irregular plan, due to the orientation of the *qibla* wall and the making of mudbricks sourced from both local and imported material. Analysis of ceramics indicated the presence of pottery largely from the Funj period. Samples taken during the season will be subject to further research.

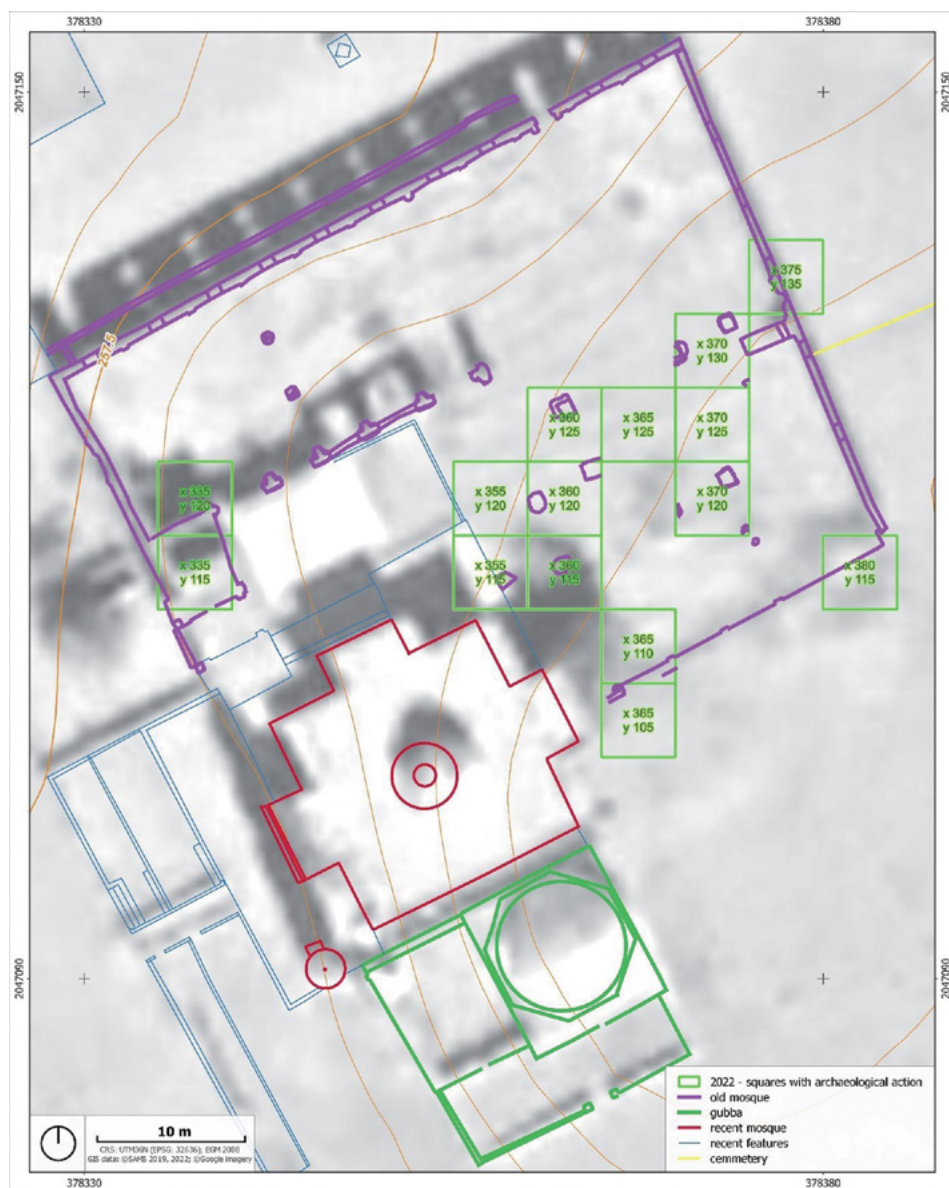
**Hudec, Fig. 1:** Map of excavations in the 2022 season (Drawing: T. Lieskovský)

The archaeological research followed up the excavations from the previous seasons.<sup>2</sup> The planned start of work in the old mosque of Duweym Wad Haj on 23 January had to be postponed by two days because of a local interment and related traditions. The archaeological excavations used five full squares (5x5 m) and five testing pits (four pits 2x2 m, two pits 1x6 m). The squares were excavated in layers and stratigraphic units (SU) to detect possible column bases or other interior structures of the old mosque. Seven fully unearthed bases of *riwaq* pillars and/or columns were documented in these squares and pits as well as four partly unearthed bases of *riwaq* pillars and/or columns, i.e. eleven architectonic items have been discovered and documented altogether (Fig.1).

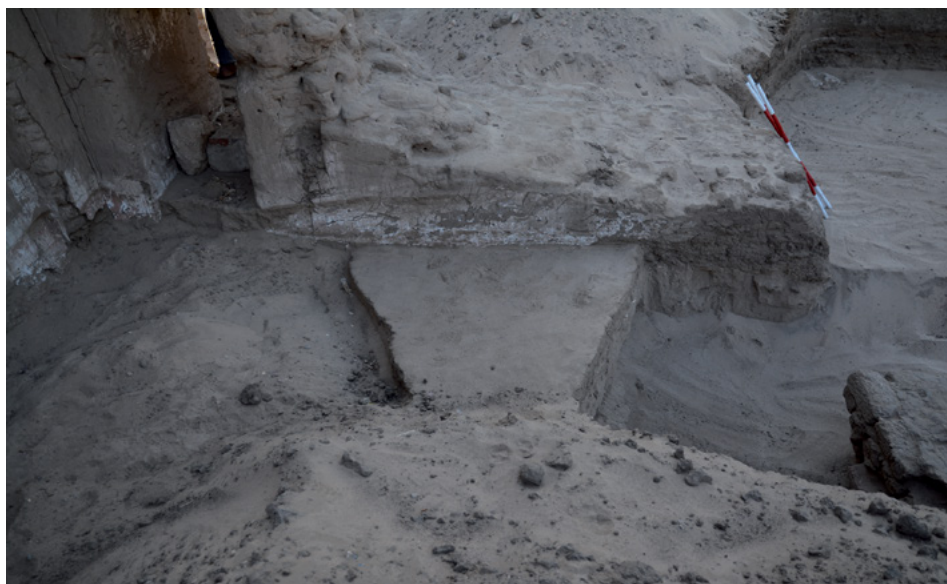
**Hudec, Fig. 2:** Minbar (SU48) extending over eastern section of the square X370Y130 and a clay floor on its northern side (Photo: J. Hudec)

The square was located close to the centre of the *qibla* wall of the old mosque. The *minbar* (SU48) extends over the eastern section into the square (Fig. 2); the surface of the *minbar* was partly studied in the 2019 season.<sup>3</sup> SU1 was approx. 40 cm thick, of a very pale brown colour (Munsell 10 YR 7/3).

building of the *minbar*. The construction of the *minbar* on the right side of the *mihrab* (Fig. 2), on the already plastered *qibla* wall, as well as the different levels of the bases of the pillars and the fundament of the *minbar* indicate that the *minbar* was built sometime after the construction of the first stage of the old mosque.

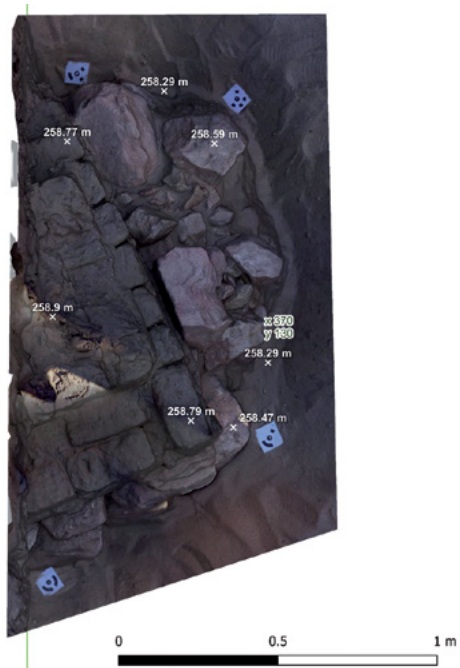
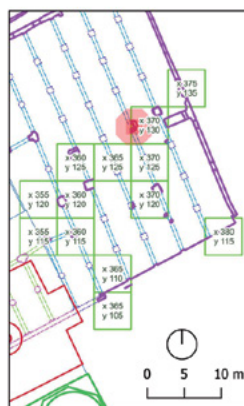
**Hudec, Fig. 3:** Part of the base of pillar SU44 in square X370Y130 (Orthophoto and plan: T. Lieskovský)

Part of a pillar base of the mosque's *riwaq* – SU44 – was found covered by the SU42 in the western section of the square (Fig. 3). Its uncovered dimensions were 100x80x60 cm and it consisted of stones and mudbricks with the dimensions 25x12x7 cm. The base was not excavated to its full extent. Three rows of the construction were identified: two consisted of mudbricks, one consisted of stones. Mud mortar was found between individual rows of the structure.

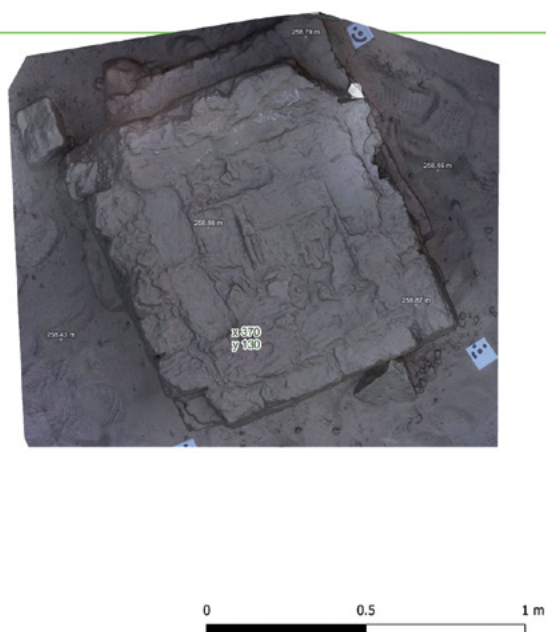
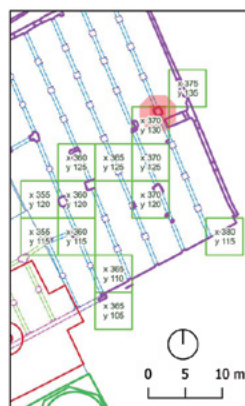
**Hudec, Fig. 4:** Base of pillar SU47 in square X370Y130 (Orthophoto and plan: T. Lieskovský)

Near the northern section another pillar base – SU47 – was found in SU42. The dimensions of the structure were 100x100x50 cm (Fig. 4) and it consisted of stones and mudbricks (26x12x7 cm). Three rows of the structure were identified: two of mudbricks, one of stone. Also mud mortar was found here between individual layers.

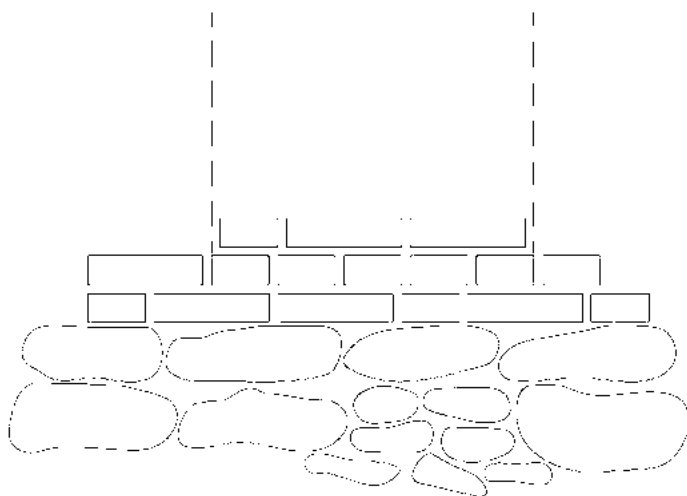
**Hudec, Fig. 5:** The typical schematic foundation of a pillar of the mosque's riwaq (Drawing: M. Černý)

A part of a stone structure (including two large stones) – SU49 – with the dimensions 50x20x20 cm was unearthed in the south-eastern corner of the square in SU42. The last part remained earthed in the neighbouring unsearched squares. The nature of the discovered structure and its location corresponds to the frame of the pillar bases of the *riwaq* (Fig. 5).

The research also focused on some selected structural parts of the mosque. Mudbrick columns were usually founded on a stone base created by two layers of stones covered by two layers of mudbricks (Fig. 5). In general, a typical mudbrick size is ca. 27x13x6 cm.

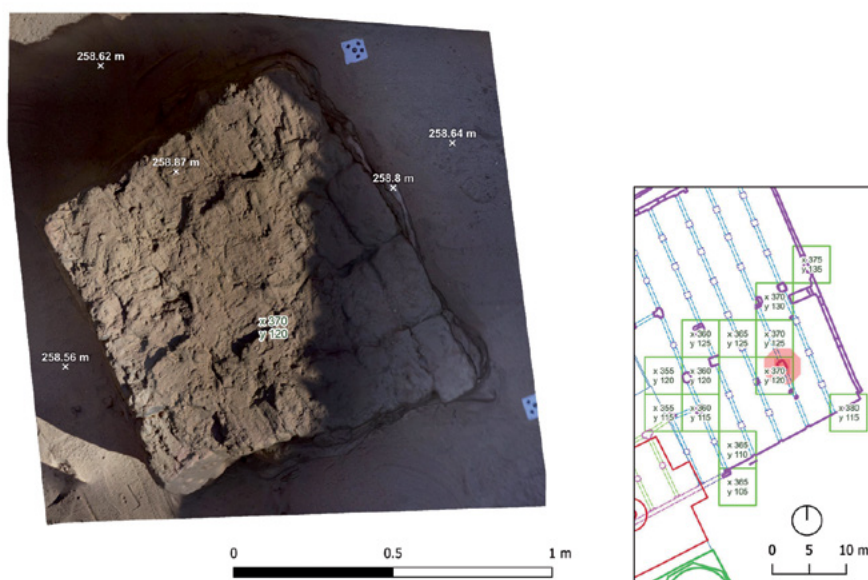
**Hudec, Fig. 6:** The quadrate stone-earthen base of pillar SU41 in square X370Y120 (Orthophoto and plan: T. Lieskovský)

Near the northern section of the square, in SU40, the quadrate stone-earthen base of a pillar SU41 (Fig. 6) was discovered. The dimensions of the base were 120x100x30 cm. It contained trimmed quadrate stones of various dimensions and mudbricks (usually with uniform dimensions of 25x14x7 cm). There were remains of mortar between them. It might have been associated with the destroyed remains SU37. Near SU41 a part of SU55 was excavated. However, both SU might be identical. The SU55 did not contain archaeological finds.

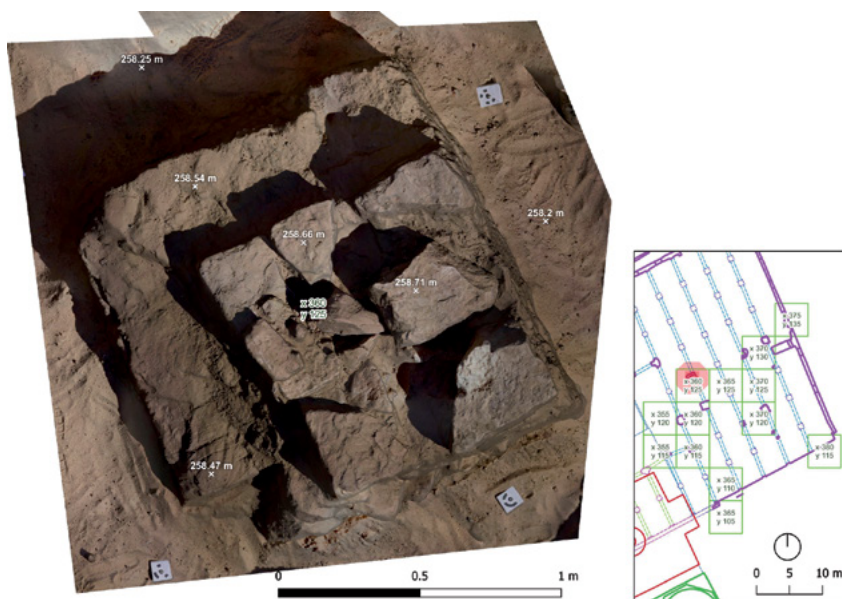
**Hudec, Fig. 7:** Masonry of SU45 supporting stone base SU36 of a pillar in square X360Y125 (Orthophotograph and plan: T. Lieskovský)

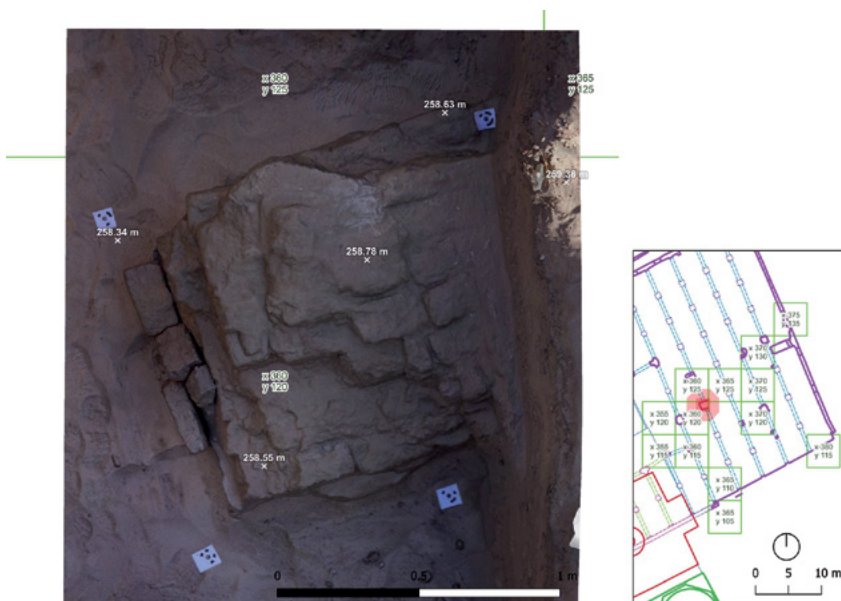
**Hudec, Fig. 8:** The angular base SU52 of a pillar in square X360Y120 (Orthophoto and plan: T. Lieskovský)

The angular base SU52 with dimensions of ca 110x120 cm (Fig. 8) consisted of two rows of mudbricks, (with dimensions of 25x10x6 cm), which were bonded by thick layers of mud mortar from the sides.

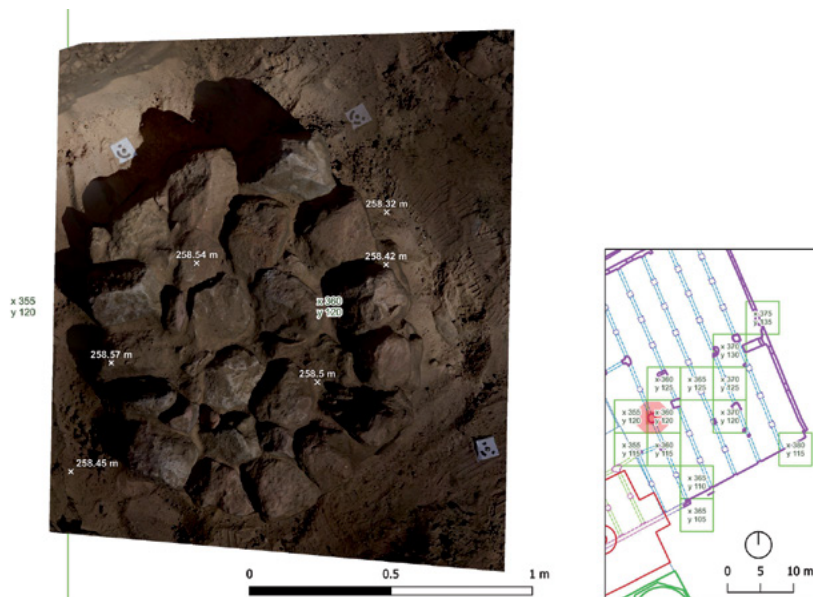
**Hudec, Fig. 9:** The oval base SU53 of a column in square X360Y120 (Orthophoto and plan: T. Lieskovský)

The oval base SU53 consisted of two rows of lime and sandstone of various shapes and sizes. Two layers of stones with mud bond were unearthed on an area of 130x110 cm (Fig. 9). A part of the western section of the square was removed to research the whole extent of the base. The construction of this base in the 5th arcade of the eastern wing of the *riwaq* was considerably different from the other four arcades. The difference could be interpreted as architectonic, as four eastern arcades consisted of pillars and the last arcade, flanking the internal yard, was constructed of more massive columns (as seen on the flank of the northern wing), which needed stronger matching bases.

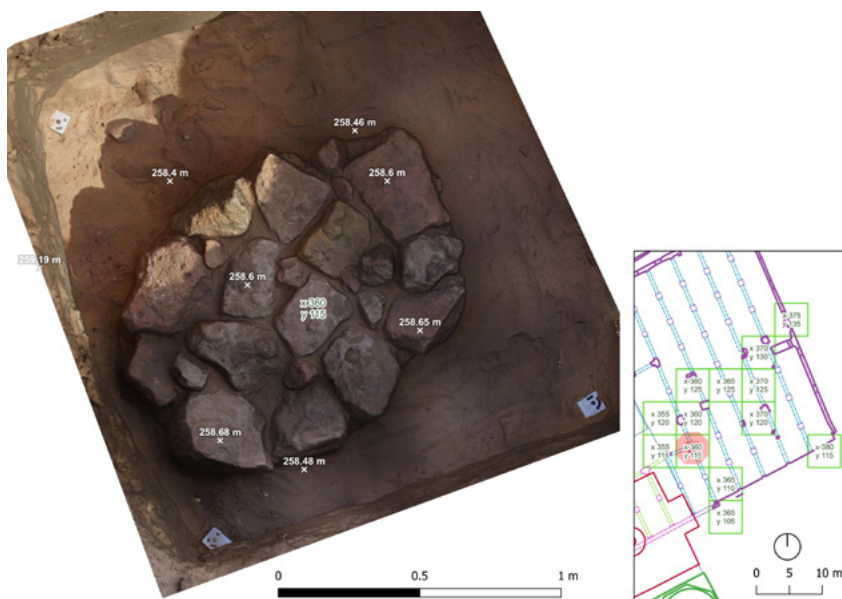
**Hudec, Fig. 10:** Oval stone base of a column in square X360Y115 (Orthophoto and plan: T. Lieskovský)

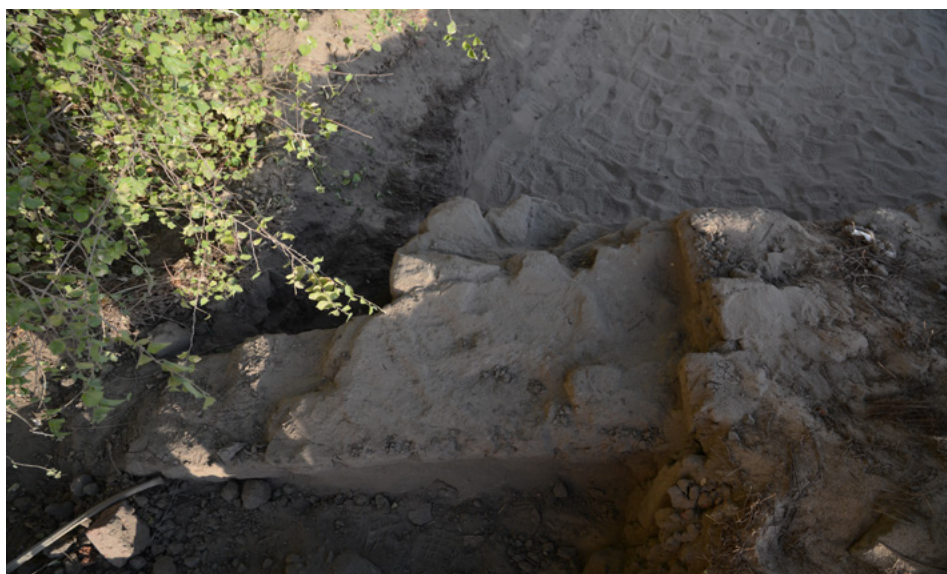
**Hudec, Fig. 11:** Tapering southern perimeter wall with  $\frac{3}{4}$  column in square X365Y105 (Photo: J. Hudec)

The unearthed pilaster of the 5th arcade showed a specific feature: it was situated in a spot where the full width of the southern wall thinned out into a half width and the resulting corner was covered up by deltoid mudbricks, creating a  $\frac{3}{4}$  column (Fig. 11). The purpose of the niche thus created, which might continue in the southern wall westwards, is unknown; it might eventually have reached a door, which led (?) towards the *gubba*. The continuation of excavations further westwards was impossible due to static concerns caused by a water tank. Also it is not known whether the collapsed southern wall included windows.

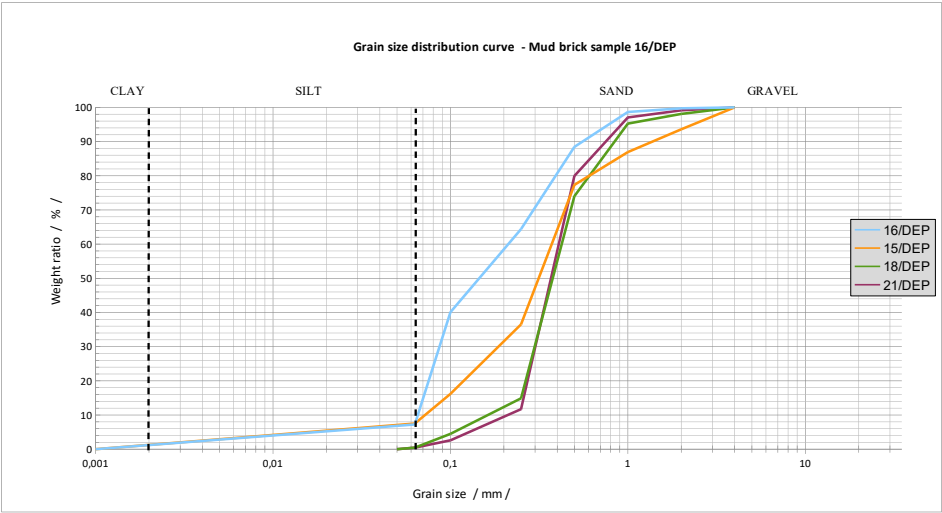
**Hudec, Fig. 12:** Grain size curve – a comparison of the sand and mudbrick sample (Graph: M. Černý)

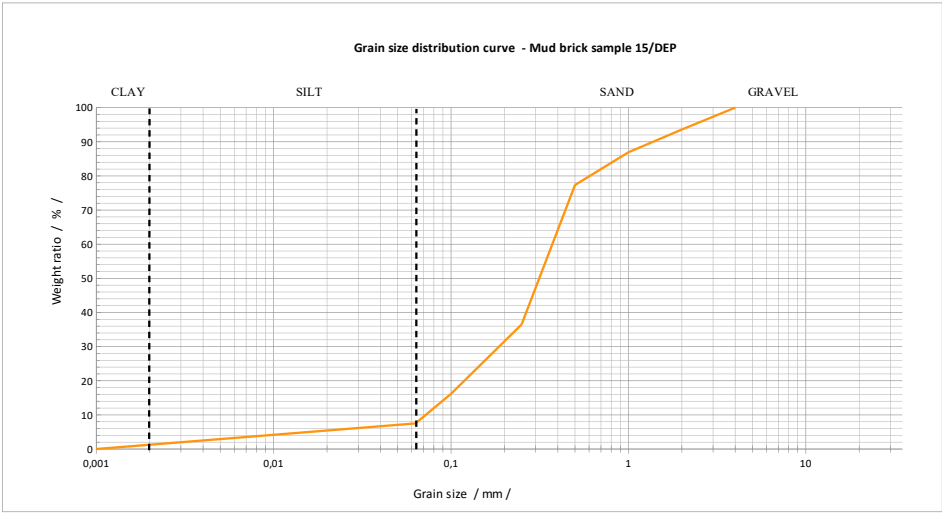
**Hudec, Fig. 13:** Grain size curve – mud brick sample 15/DEP (Graph: M. Černý)

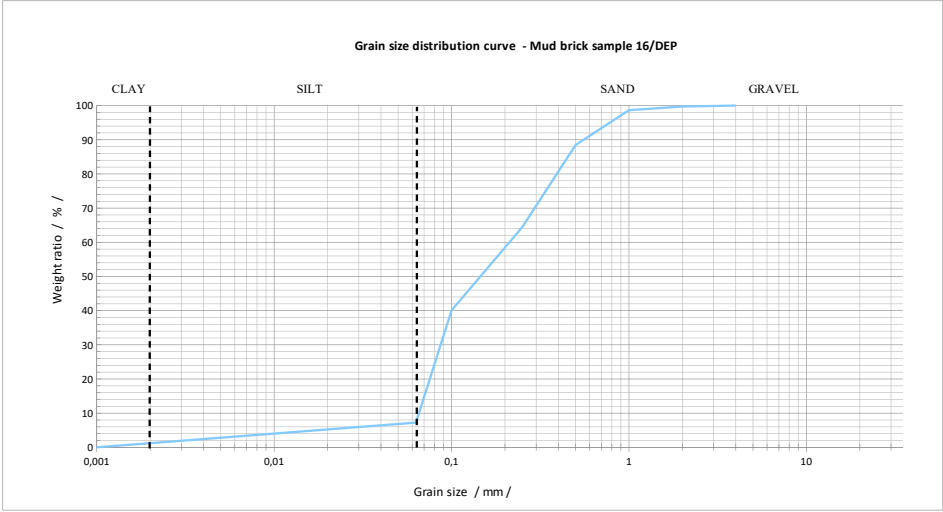
Hudec, Fig. 14: Grain size curve – mud brick sample 16/DEP (Graph: M. Černý)

However, based on a composition of the mudbrick 16/DEP from the southern foundation of the walls of the old mosque, it is possible to assume a different type of sand, which contains much smaller sand particles. Maybe some of the mudbricks were delivered to the site from different places where they were made. For a more precise hypothesis it is necessary to extend the database of samples and cooperate with archaeological research which brings new knowledge.

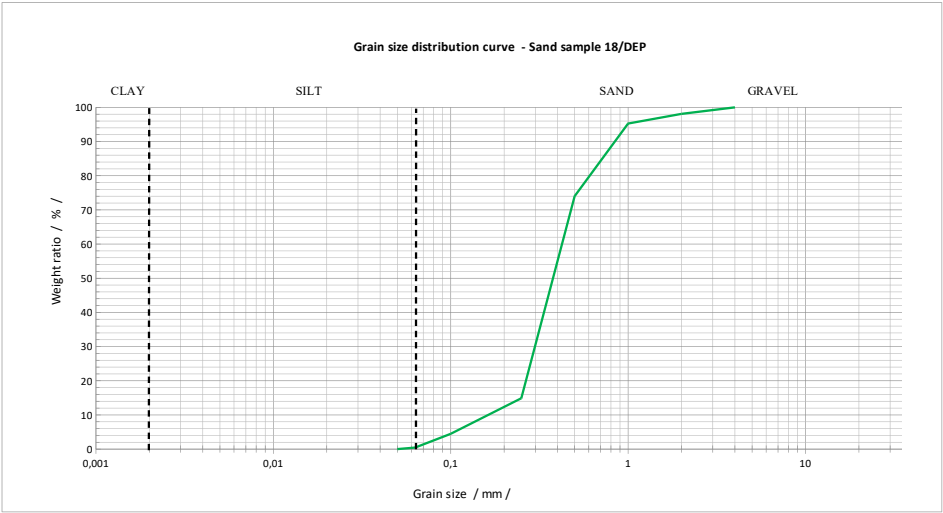
Hudec, Fig. 15: Grain size curve – sand sample 18/DEP (Graph: M. Černý)

According to a very clear consensus of the sand samples 18/DEP and 21/DEP, it is possible to assert that the same local sand was used in the foundation area of the southern wall and on terrain inside the mosque, probably at the same time.

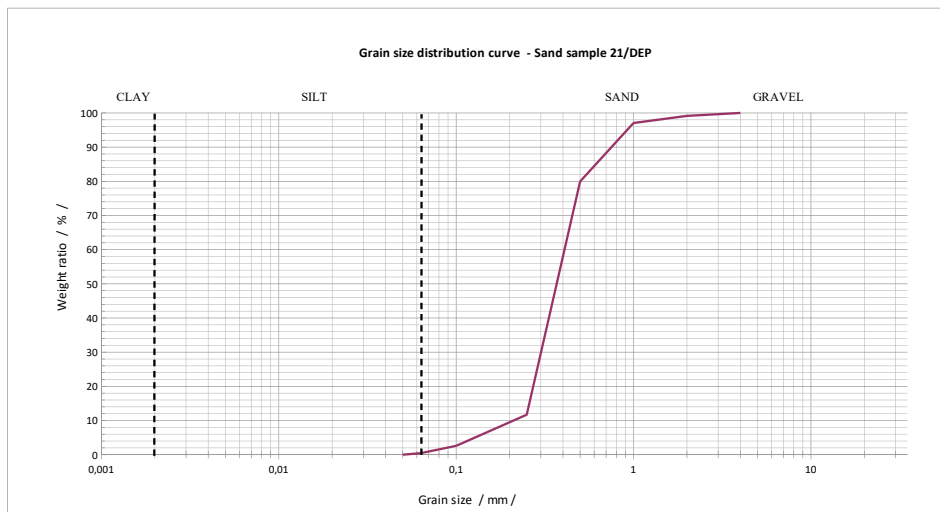
**Hudec, Fig. 16:** Grain size curve – sand sample 21/DEP (Graph: M. Černý)

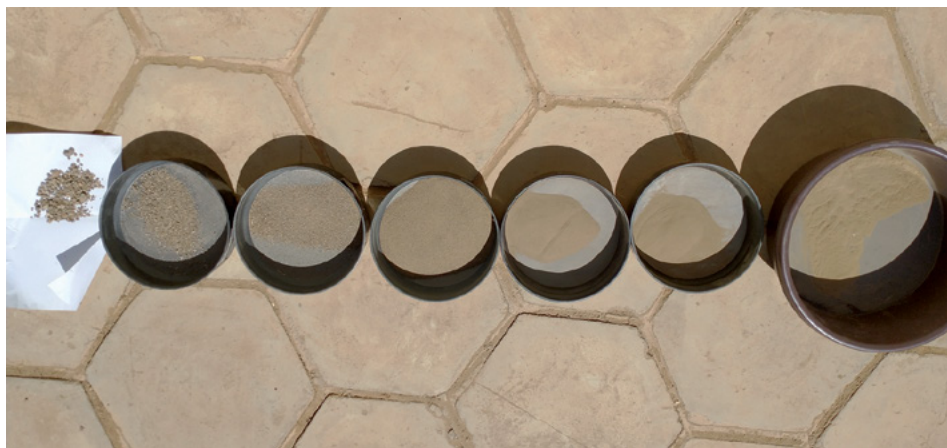
**Hudec, Fig. 17:** Sieve analysis at the site (Photo M. Černý)

For mudbrick we also know, for example, the recommended limits of the type of material used, the suitable grain size curve slope, etc. In addition, data obtained from a mudbrick comparison help to illustrate the relationship between constructions and their material. A brief description of grain size distribution curves for mudbrick and soil samples is given in Fig. 12. A sieve analysis of the sand and mudbrick samples carried out during the excavation is shown in Fig. 17.

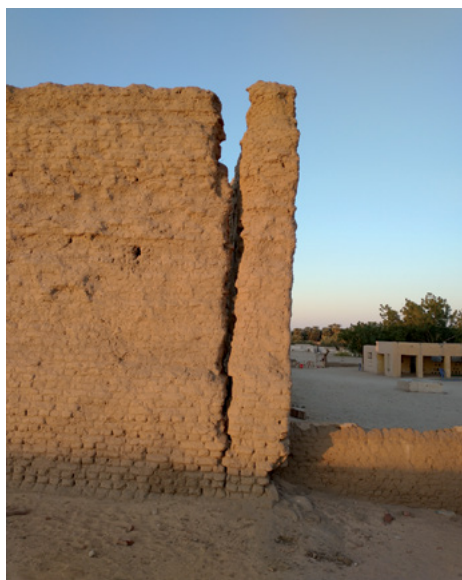
**Hudec, Fig. 18:** Eastern view of the corner wall crack (Photo: M. Černý)

Some stabilization problems have been identified at the north-eastern corner of the old mosque, northern wall of which is leaning towards the outside. A huge crack is visible at the north-eastern corner from inside and outside (Fig. 18) as well as beside the north-western corner (Fig. 19).

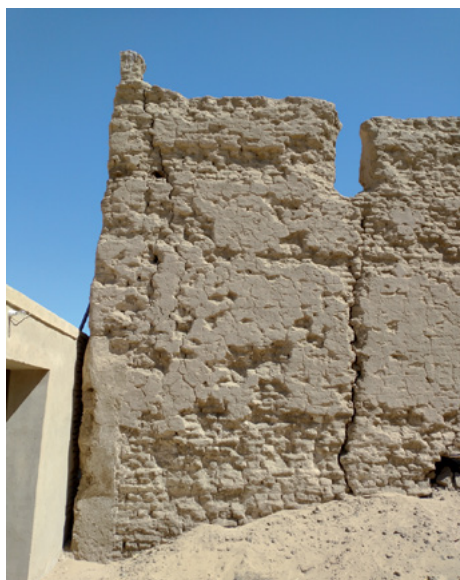
**Hudec, Fig. 19:** Western view of the corner wall crack (Photo: M. Černý)

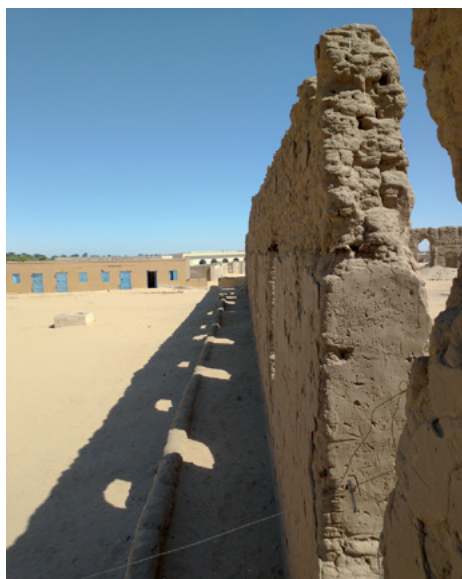
**Hudec, Fig. 20:** A stabilizing retaining wall along the northern wall (Photo: M. Černý)

Terrain constraints are confirmed also by the leaning of the northern wall, probably caused by a stability problem associated with the sloping terrain. Temporarily, the stabilisation of the northern wall was solved, probably during the construction of the mosque or very soon afterwards, by the building of a retaining wall. It was built along the northern perimeter wall, from the north-eastern side gate to north-west corner, to stabilize the northern wall of the old mosque (see Fig. 20).

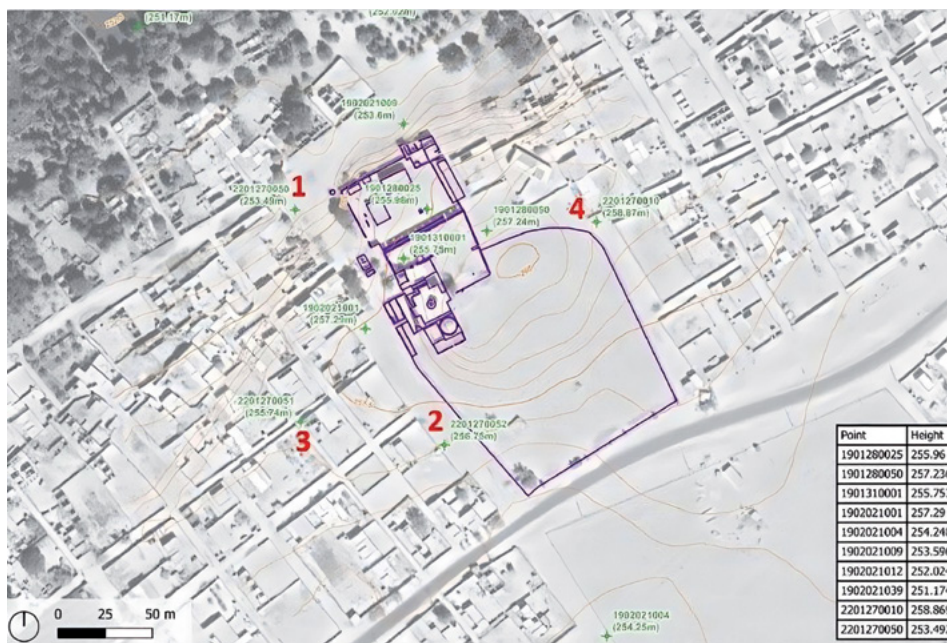
**Hudec, Fig. 21:** Distribution of the soil profiles studied at Duweym Wad Haj. The soil profiles made in the 2022 season are designated by red numbers (Drawing: T. Lieskovský)

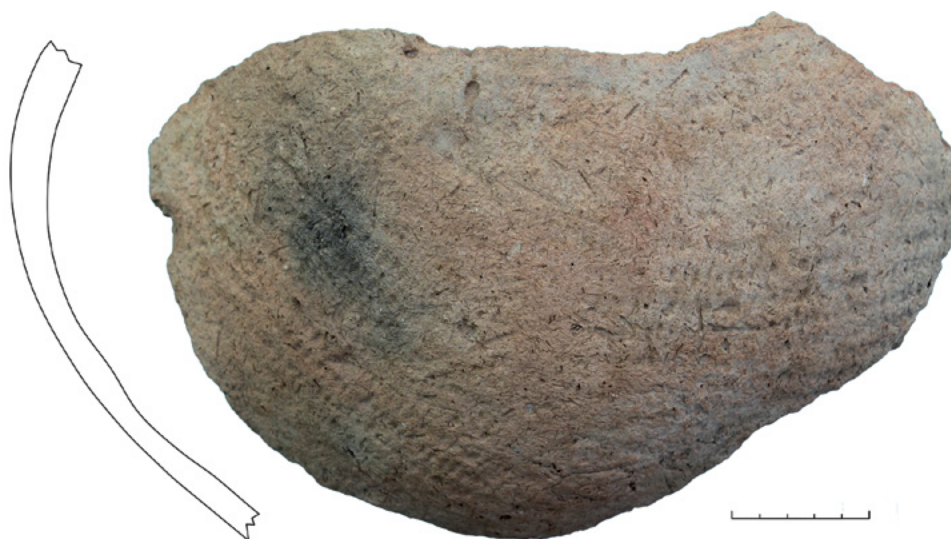
**Hudec, Fig. 23:** Pottery fragment of a post-Meroitic jar (Photo and drawing: L. Horáková)

One of the biggest pottery fragments recovered during the field season in 2019 may possibly come from a post-Meroitic jar (Fig. 23). These fragments differed from the majority of pottery from the site in their forms of decoration and fabric. However, the pre-Funj pottery at the site is rather scarce.

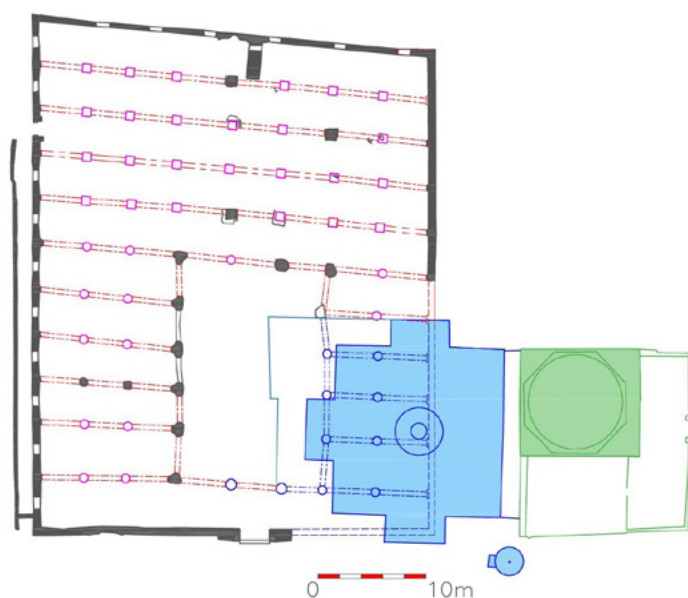
**Hudec, Fig. 25:** Layout plan of the old mosque. Black colour – old mosque's remaining parts, red colour – reconstructed parts, blue colour – the new mosque, green colour – the gubba (Drawing: M. Černý, T. Lieskovský)

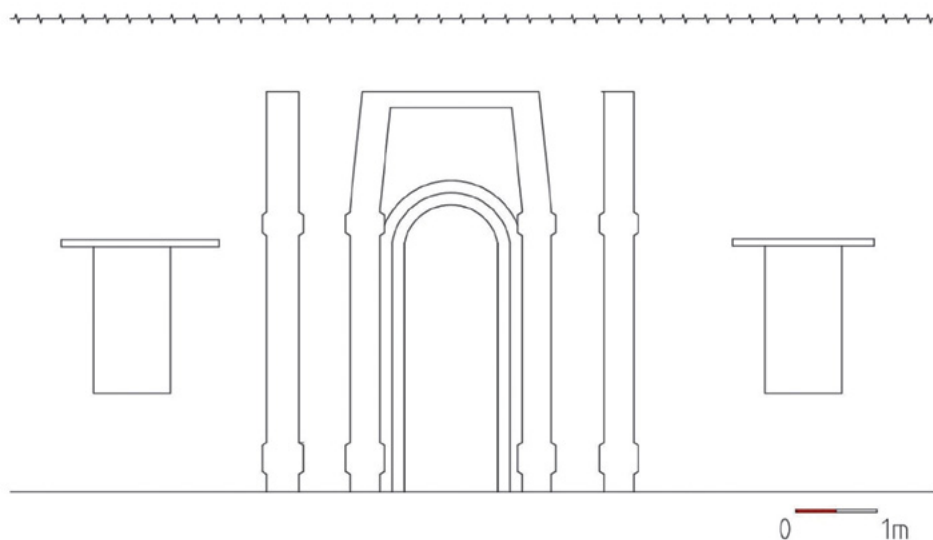
**Hudec, Fig. 26:** The side gate in the northern wall – outside view (Drawing: M. Černý)

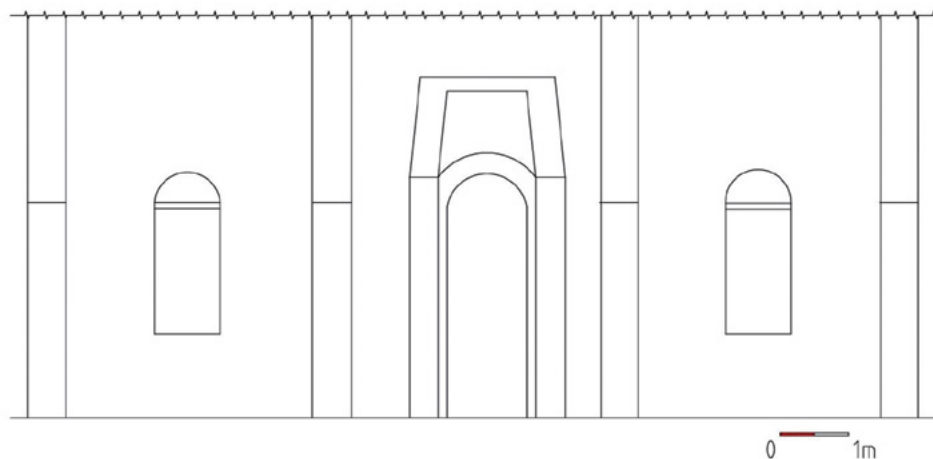
**Hudec, Fig. 27:** The side gate in the northern wall – inside view (Drawing: M. Černý)

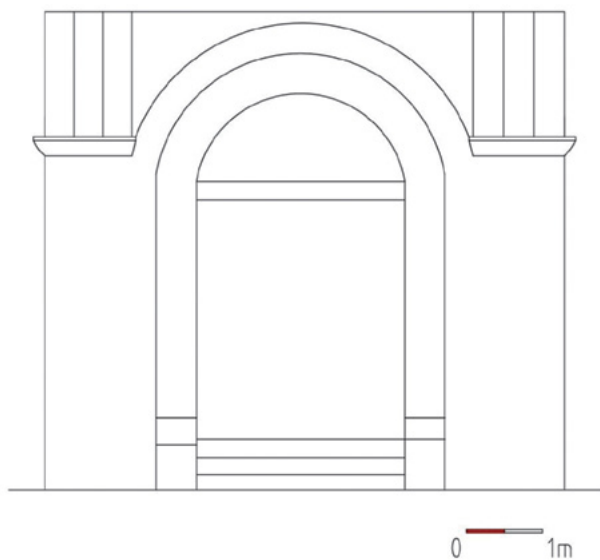
**Hudec, Fig. 28:** Main gate in the western wall – outside view (Drawing: M. Černý)

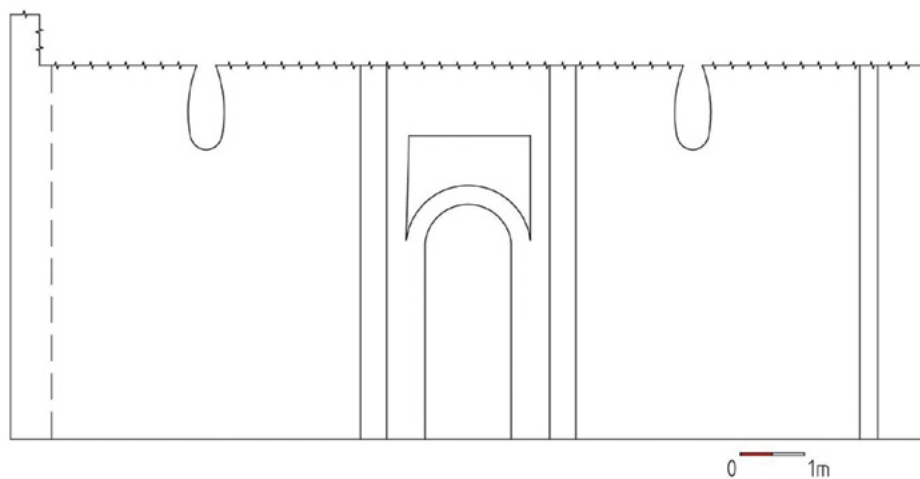
**Hudec, Fig. 29:** False gate on the western wall – outside view (Drawing: M. Černý)

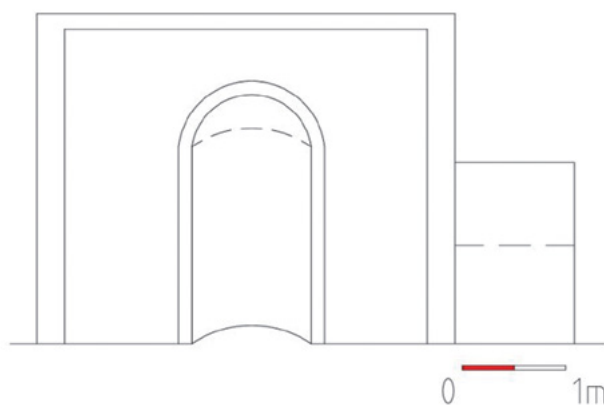
**Hudec, Fig. 30:** Mihrab with minbar on the right side (Drawing: M. Černý)
